### CASE STUDY THREE

## DURABILITY: BRIDGE IN THE NETHERLANDS AFTER 60 YEARS

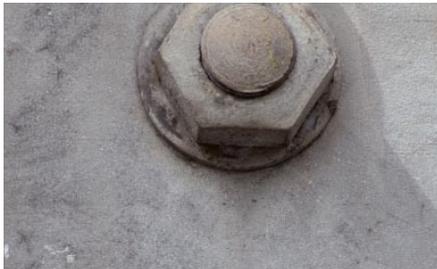
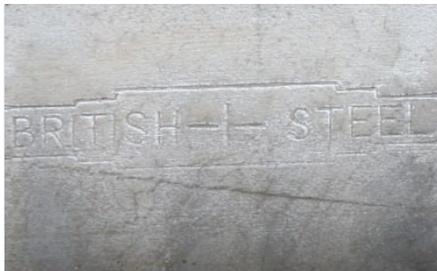
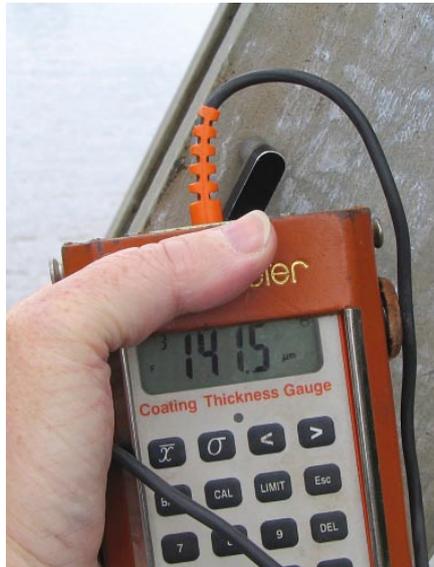
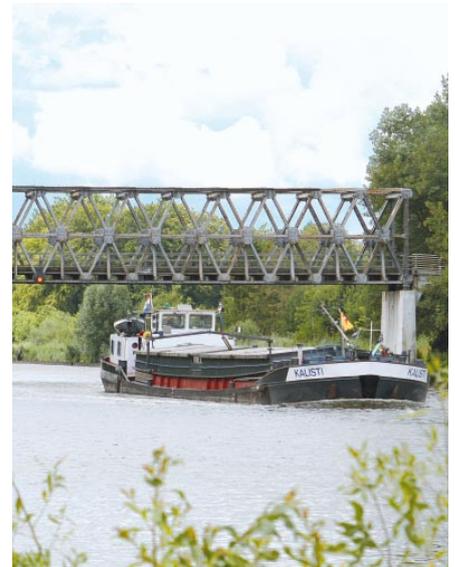
The bridge was recently inspected by technical staff from the Dutch Galvanizers Association (SDV) who were struck by the good appearance of the bridge, which was characterised by a dull grey galvanized coating with only some light rust staining.

Some remedial work had been done in the vicinity of the bolted connections and youngsters with their spray cans had also contributed to the appearance of the bridge! Most importantly, the steel structure itself had not suffered any significant corrosion.

During the inspection, coating thickness was electromagnetically determined in a number of randomly selected areas, using an average of 10 readings at each location. At three diagonal bracing sections (150 x 150 mm) coatings of 74 $\mu$ m, 115 $\mu$ m and 219 $\mu$ m were found. At two other diagonal sections (130 x 130 mm) coatings of 69  $\mu$ m and 82  $\mu$ m were found. Two connecting plates were found to have coatings of 114 $\mu$ m (19 mm steel thickness) and 86 $\mu$ m (9 mm steel thickness).

In comparison with the thicknesses of the zinc layers as reported by Dutch galvanizing expert, Van Eijnsbergen, 25 years after the bridge was built there appears to have been no significant reduction of the coating thicknesses.
